Antun Mikulecky
Končar - Electrical Engineering Institute
amikul@koncar-institut.hr

TRANSFORMER BUSHINGS – FAILURE CASE STUDIES

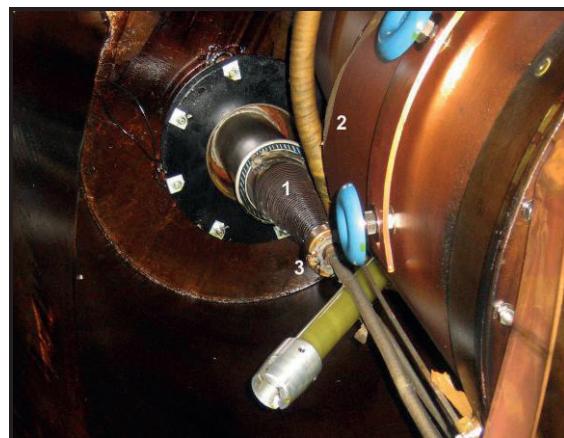
The lower envelope of an OIP type 123 kV bushing on a 150 MVA, 220/110 kV autotransformer, voltage, about 40 years old, exploded in the spring of 2006, during heavy rain, Figure 3. The hydrodynamic shock caused by bushing breakdown was very intense. The transformer tank was ruptured in several places so oil was leaking out. Most of the remaining bushings on the transformer were damaged (upper porcelain envelope damage and dislocation in relation to the head or flange occurred, followed by oil leakage from the bushing). The active part of the transformer was damaged to a great extent (the OLTC was destroyed, tap winding leads were damaged, etc.) and polluted so it had to be scrapped. The bushing was connected to the switchyard by rope.

Figure 3: Exploded 123 kV bushing
(1 – lower part of the bushing without the exploded lower envelope,
2 – damaged diverter switch cylinder,
3 – electric arch traces on the lower electrostatic screen)

The transformer was regularly diagnostically tested in approximately four-year intervals. In the period between the last two measurements in the years 2002 and 2005, there was a relatively large increase of the bushing $\tan\delta$ amounting to 41 %, but its value was still relatively low (0,52 %). The bushing was treated as suspicious and more frequent testing was recommended. A detailed inspection of the bushing debris was performed several months after the failure. The condenser body was unwounded but no traces pointing to the cause of failure were found. The lower part of the condenser body was clean, with no traces of an electric arch. Traces of an electric arch were found only on the lower porcelain envelope fragments that were collected from the transformer tank, flange and lower electrostatic screen.

The following failure scenario can be presumed. Weakening of the sealing system leads to a gradual moistening of the bushing insulation system resulting in an increase of $\tan\delta$. Due to heavy rain and rapid cooling of the bushing, water can be sucked into it and this directly causes the lower envelope crepe breakdown (position 8 in Figure 1). Such a hydrodynamic shock breaks the OLTC diverter switch cylinder thus causing the loss of its axial support. Hence, the OLTC drops and moves to the side, deforming 123 kV line lead and on the tap winding leads in the process. Based on this case, it can be concluded that a forty percent increase of $\tan\delta$ is very significant, despite its relatively low value. The recommendation for more frequent measurement was not good enough. The failure could have been avoided by replacing the bushing or adding an intervention monitoring system.

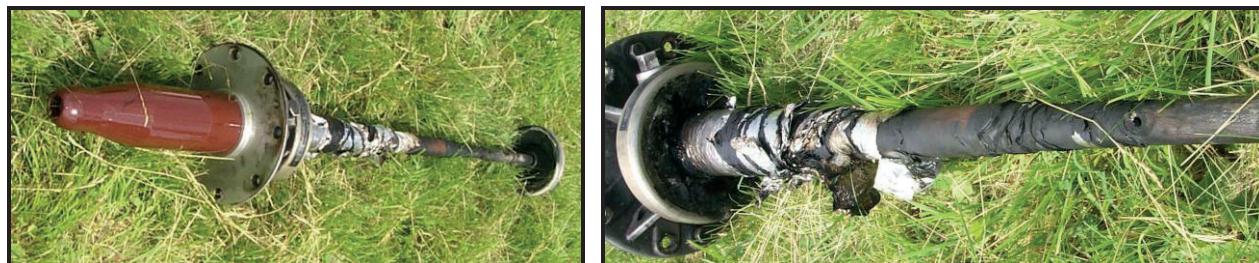
In the spring of 2005, the upper envelope of the 123 kV OIP type bushing on a 40 MVA, 110/10.5 kV transformer, 20 years old, exploded. The shock caused damage to the other bushings and equipment in the switchyard as well as a small fire. The failure occurred during a thunderstorm. Previous diagnostic investigation of the bushing had been undertaken in the years 1996 and 2000, approximately nine and five years previous to the failure, respectively. In that period, $\tan\delta$ increased by almost 50 % (from 0,17 % to 0,25 %), but the values were very low, even for new bushings. The bushing was connected by rope. All 123 kV bushing were replaced in a few days. Visual inspection of the bushing debris showed a longitudinal breakdown in the space between the condenser body and the upper envelope (space between positions 1 and 7 in Figure 1). This is implicated by the hole on the central tube caused by the electric arch during the breakdown, Figure 4. However, because of the great damage of the condenser body, most part of which was burnt, a possible cause of breakdown could also have been the condenser body breakdown, although in this case it is less likely. The lower envelope was not damaged; preventing oil leakage onto the fault site and thus it was not accompanied by a major fire or transformer active part pollution by bushing fragments. An inspection of the bushing head showed cracks that could have occurred prior to the failure and this fact could be considered as an initial sealing system defect.

Figure 4: Disassembled failed bushing; Figure left – the whole bushing; Figure right – upper part of the bushing (the hole on the right-hand side of the tube was caused by the electric arch)

The cause of this bushing failure is not completely clear. Possibly, it was caused by a defect in the sealing system or a defect of the bushing condenser body. This case also points out the importance of $\tan\delta$ change during service despite very small actual values.

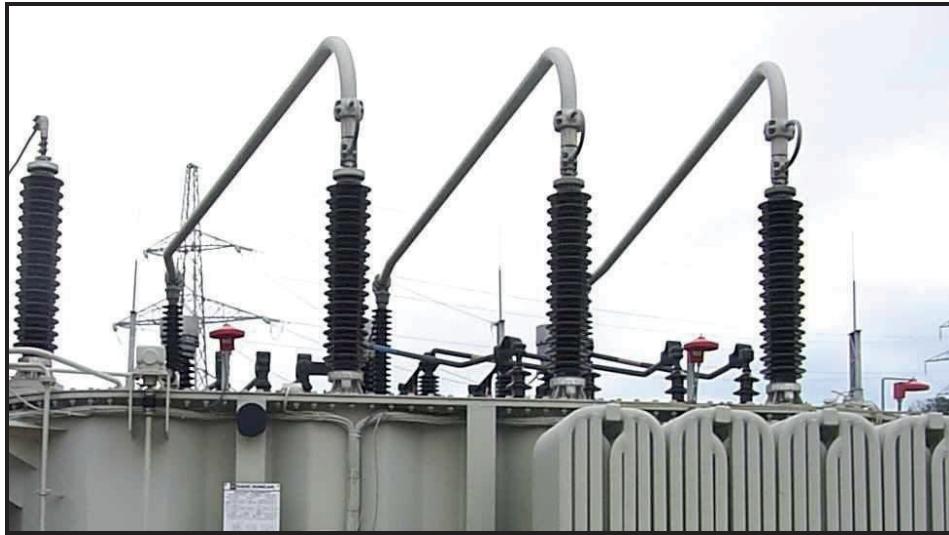
In the period of 1991 to 1998, three 123 kV OIP bushing explosions occurred on three GSU transformers 43 MVA, 115 kV in one hydro-power plant. Frequent on and off switching, just as service at full load is characteristic for this power plant (peak load power plant). In all three cases, the failure appearance was practically identical: HV bushing explosion, thus damaging the other HV and LV bushings, causing a fire that further damaged the entire transformer exterior. Each time, repairs lasted for several months and had to be conducted in the factory. The bushings were connected to the switchyard by tubes, as shown in Figure 5. The first failure occurred in 1991 on a transformer produced in 1981. No data on previous diagnostic investigations were available. According to the visual inspection, the burst progressed radially from the central bushing tube (pos. 6 in Fig. 1) to the flange in the test tap area (positions 9 and 11 in Figure 1). The second failure occurred in 1993 on a transformer also produced in 1981. The inspected breakdown traces were visually identical to the first case. Previous diagnostic investigation had been conducted 14 months prior to the failure, but the results did not show any problems. The third failure occurred in 1998 on a transformer produced in 1988. Breakdown traces progressed axially, from the upper endpoint of the bushing, through interspace between bushing condenser body (pos. 1, Fig. 1) and porcelain (pos. 7, Fig. 1), to the flange in the test tap area (positions 9 and 11 in Figure 1). Previous measurement of $\tan\delta$, approximately 13 month before the failure, had shown a value of 1,52 %, but, unfortunately, despite this drastic increase in value, the bushing had not been replaced. The three exploded bushings were not produced by the same manufacturer. Traces of all the three breakdowns were in a way associated with the test tap.

Figure 5: Tubular connections between the switchyard and 123 kV bushings

Obviously, these three cases show that something causes bushing properties degradation. The assumption has been made that it is caused by the too rigid tubular connection between the bushing and the switchyard. In addition, the incorrect orientation of the bus dilatation compensator contributes to the degradation (see Fig. 5). It can compensate vertical but not horizontal dilatation, whereas the latter should be dominant. A replacement of the bushing – switchyard connection was recommended. Instead, a part of a tubular connection flexible cable (rope) was used. Switchyard reconstruction was performed approximately twelve years ago and since then there have not been any malfunctions of this type.

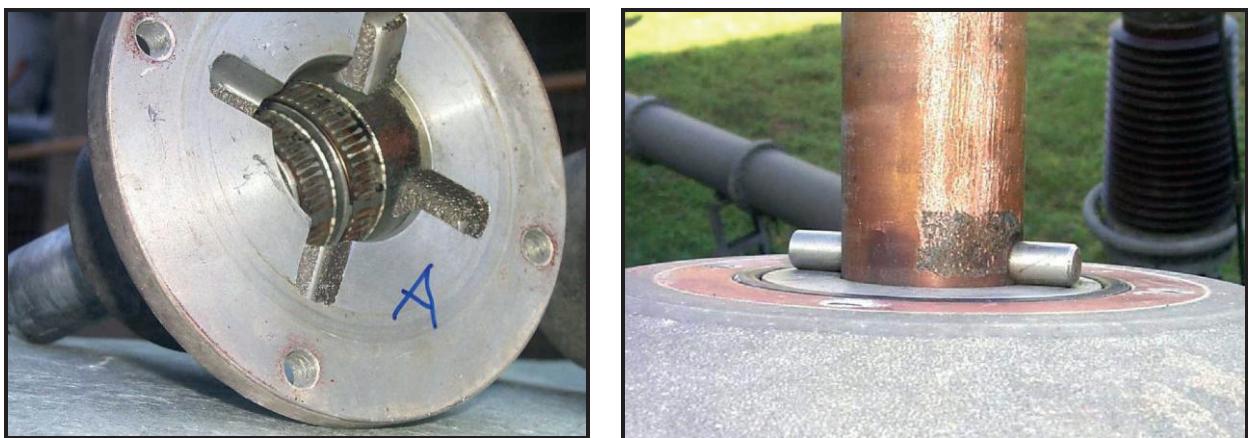
Thermal image scanning of the 250 MVA, 220 kV, 16 years old, GSU transformer in 2002 showed increased heating of the 245 kV bushing head and connection (positions 3 and 4, Figure 1) relative to a healthy bushing, approximately by 60 K. Measurement of the HV Winding resistance showed an increase of 0,87 % in the respective phase therefore indicating the cause of poor contact on the tulip contacts (pos. 3, Figure 1) between the connection and the bolt at the end of the copper cable, Figure 6. Inspection of the HV connection showed traces of metal melting on the tulip contacts and copper transfer from the bolt to the aluminum connection. This incipient failure was eliminated by replacing the tulip contacts spring part, since its weakening is the most probable cause of increased heating, and by cleaning contact surfaces. Owing to the availability of spare parts as well as to detection of the malfunction in the initial stage, repairs took only two days.

Figure 6: Left: Overheating traces on the HV connection and the tulip contact spring part;
Right: Traces of overheating on the bolt

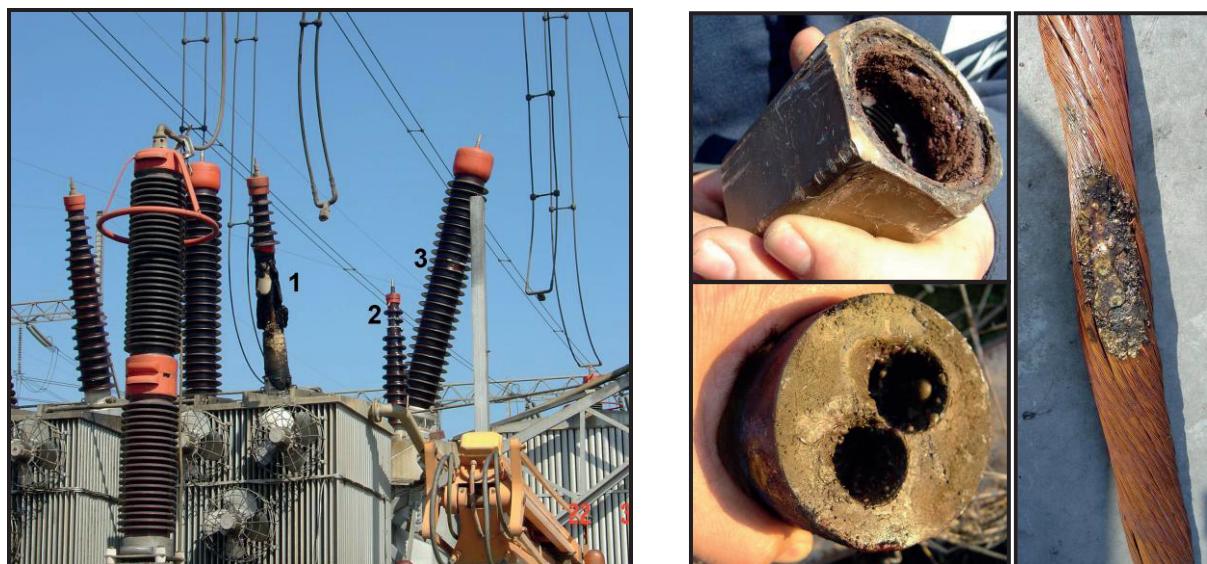
Figure 7: A 400 MVA, 400 kV transformer failure;

A very interesting 245 kV RBP bushing failure in the form of upper envelope and lower bushing part explosion occurred in 2005 on a 400 MVA, 400/220/30 kV, approximately 25 years old transformer. It was accompanied by a small scale fire on the transformer and pollution of the active part by the bushing fragments and other carbonized residues. Upper envelope fragments destroyed the neutral point bushing and one 420 kV bushing sustained damage, Figure 7. No information on diagnostic tests in the period of 5 years prior to the failure was available. Visual inspection of the bushing indicated a radial condenser body breakdown. Based on a detailed inspection of the bushing, the following probable failure scenario was established. Poor contact on the screw of the upper connection and the connector body (pos. 3, Figure 1) caused overheating which, enhanced during service, resulted in melting of the brazing by which copper cables were fixed to the connector body (Figure 7, in the middle top and bottom). Physical separation of the connector body and the cables occurred. Conduction of the current from the connector body was taken over by the central bushing tube. Electricity flowed from the tube onto the copper cables through several undefined locations, this being the only possible way to close the electric circle between the switchyard and the winding. Losses on undefined contacts heated the central tube (Figure 7, right) and bushing insulation, leading to condenser body thermal breakdown as a final consequence. Observed overheating traces suggested that the process took a relatively long time to develop and it is not clear why overheating was not detected by the thermal image scanning (generally performed once a year), which could have resulted in prevention of the bushing terminal failure, as it had been done in the previous case. Both failures were physically identical, but in the former case overheating was detected by thermal image scanning and fixed on time, with minimal costs and minimum down-time.

These two cases clearly show how incipient failure develops into terminal failure and how the absence of bushing condition diagnostics leads to terminal bushing failure, accompanied by great costs and long down-time.

Figure left: 1 - burst 245 kV bushing, 2 - destroyed 170 kV neutral point bushing, 3 – damaged 420 kV bushing;

Figure middle top: traces of overheating on the top connection;

Figure middle bottom: connecting bolt body torn off cables;

Figure right: melting trace of brass central bushing tube on the copper rope

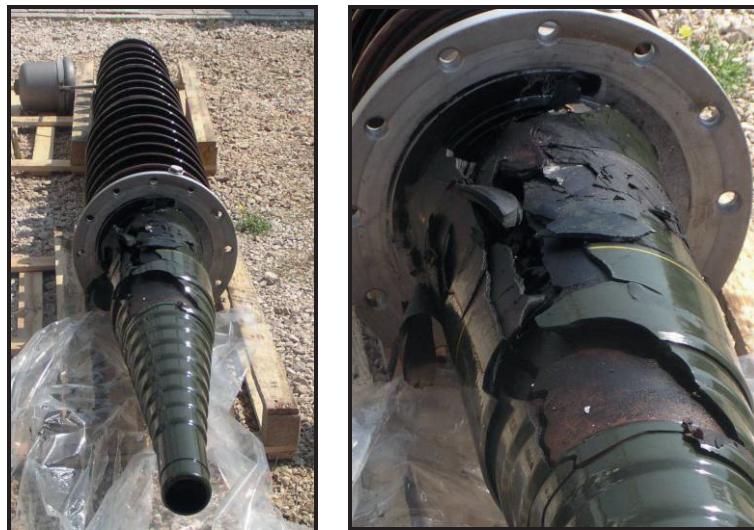
A failure of a 150 MVA autotransformer, approximately 30 years old, occurred in the spring of 2003. No special indications pointing to the failure mode were visible on the outside. Inspection of the disassembled RBP type bushing showed a burst of the bushing condenser body lower part (pos. 1 in Fig.1), approximately 0,5 m long, Figure 8. The transformer and, especially, the area around the 220 kV winding lead was intensely polluted by the bushing fragments, carbonized insulation and electrodes. Diagnostic tests of the bushing had been undertaken almost eighteen years prior to the failure but there had been no indication of the problem. The connection to the switchyard was flexible, by rope. The cause

of this breakdown is not known. However, breakdown traces indicate thermal breakdown with a wear out being a possible cause. According to the author's information, the transformer was scraped.

Figure 8 Burst of a 245 kV, RBP type, bushing, the upper porcelain envelope remained intact (left), detail of the burst lower part (right)

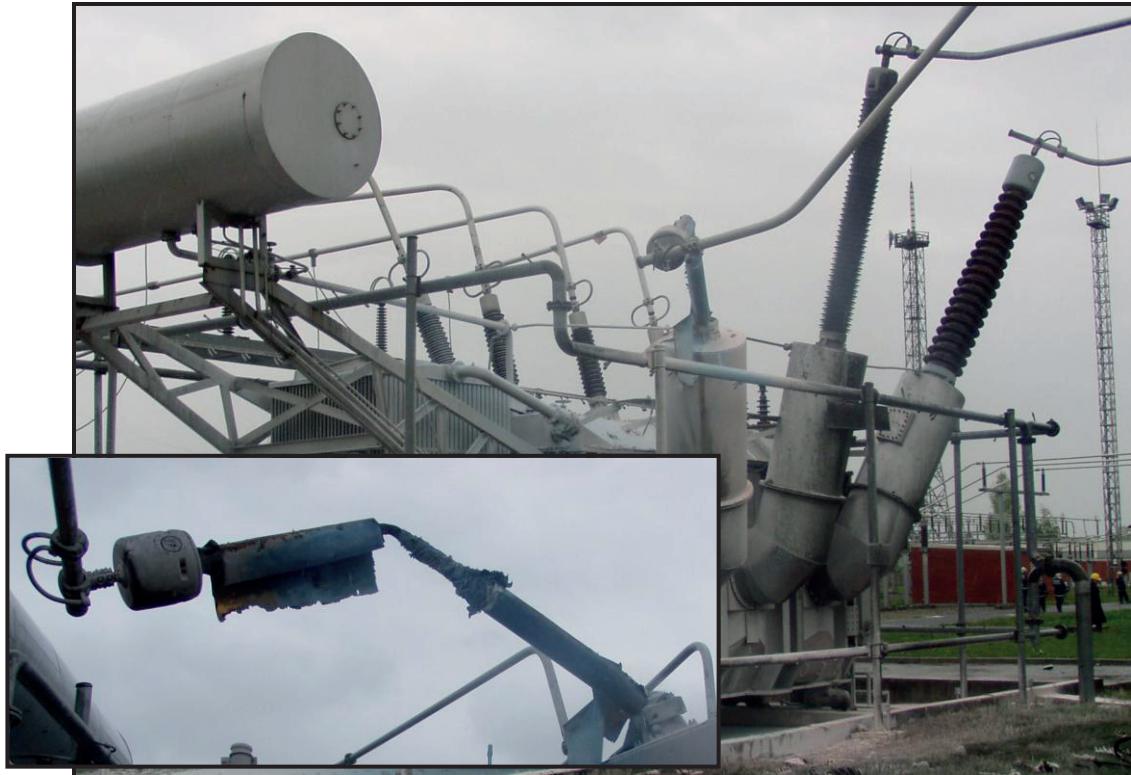
Two 400 kV bushing failures occurred on a 300 MVA, 400/110 kV autotransformer, one in 1994, the other in 2003, therefore after approximately 8 and 17 years of service, respectively. The bushings were of OIP type, connected to the switchyard by tubular connections, Figure 9. The first failure was of the incipient type – diagnostic tests showed a $\tan\delta$ of 2,2 % indicating a high degree of service unreliability. Visual inspection and DGA of oil confirmed the findings. Traces of carbonized oil and considerable concentration of gases resulting from the electric arch (or very strong PD) were detected. Previous diagnostic tests had been performed in 1989, when similar $\tan\delta$ of approximately 0,22 % had been found on all three bushings. The bushing was replaced with a spare one with down-time lasting a few days.

The second failure was terminal – an explosion followed by a fire, Figure 9, that could not be put out by the fire protection equipment (water spray system) because bushings are, because of large size, outside its action perimeter. Bushing fragments considerably polluted the transformer, but mostly remained inside the bushing turret. The dynamic shock damaged the 400 kV winding lead. The damages were, with a certain risk, fixed on site, with down-time lasting a few weeks. Traces of breakdown on the bushing condenser body indicated radial breakdown, most probably on the flange level. Diagnostic investigation had been conducted approximately three years prior to the burst, but did not indicate any defects ($\tan\delta$ was 0,23 %).

Figure 9: Bushing terminal failure in 2003 and traces of fire on the 300 MVA, 400 kV autotransformer; The right-hand bushing in the figure was replaced after an incipient failure in 1994. Detail shows the bushing debris and the tubular connection dilatation compensator

It can be presumed that the cause of accelerated bushing degradation could be the tubular connection, even with the applied dilatation compensator (in this case correctly oriented). Service experiences point to the possibility that the compensator can become blocked (seized) after long-term exposure to atmospheric influences, temperature variations etc, after years of service.

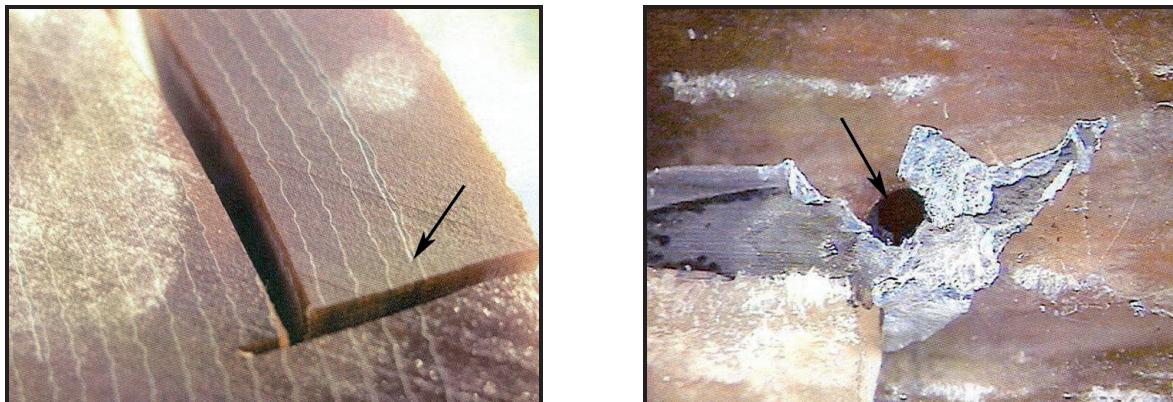
On the 350 MVA, 400/110 kV autotransformer, two almost identical incipient failures of the RIP type bushing occurred approximately one after another, the second one after three years service. The monitoring system registered a change of approximately 3 % in the 420 kV bushing capacitance, indicating a breakdown between neighboring condenser electrodes. It was confirmed by measurements on the site and on the dismantled bushing in a high-voltage laboratory. The $\tan\delta$ measured before and after the increase of capacitance, practically had not changed. The bushing was replaced with the down-time lasting several days. After dismantling, the bushings were examined in order to locate the breakdown. Results showed that it had occurred between the last condenser electrode (connected to the test tap) and adjacent electrode to it (breakdown across C_{1n} on Fig. 2), Figure 10. The exact puncture location was finally determined by microscope. Visually, the breakdown trace was a hole, around half a millimeter in diameter, stretching from the last electrode to the one before last, designated by the arrow.

In these two cases, the monitoring system proved reliable for fast detection of bushing capacitance changes. The observed traces matched with the measured capacitance values.

Figure 10: Breakdown position site; Figure left - the puncture is in the material at the depth about 1 cm from the point marked by the arrow; Figure right – the arrow designates the puncture between two electrodes (photo under microscope at magnification x15)
