Antun Mikulecky
Končar - Electrical Engineering Institute
amikul@koncar-institut.hr

TRANSFORMER BUSHINGS – FAILURE CASE STUDIES

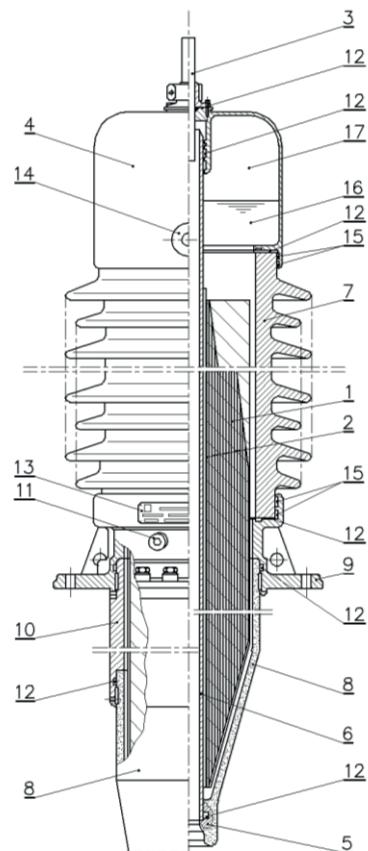
Figure 1: Drawing of the oil – air OIP type bushing

Designations, Figure 1:

- 1 – Condenser body
- 2 – Electrodes
- 3 – HV connection
- 4 – Head
- 5 – Electrostatic screen
- 6 – Central tube
- 7 – Upper envelope
- 8 – Lower envelope
- 9 – Flange
- 10 – Flange extension
- 11 – Test tap
- 12 – Sealing
- 13 – Marking plate
- 14 – oil gauge
- 15 – Binding cement
- 16 – insulating oil
- 17 – Expansion space

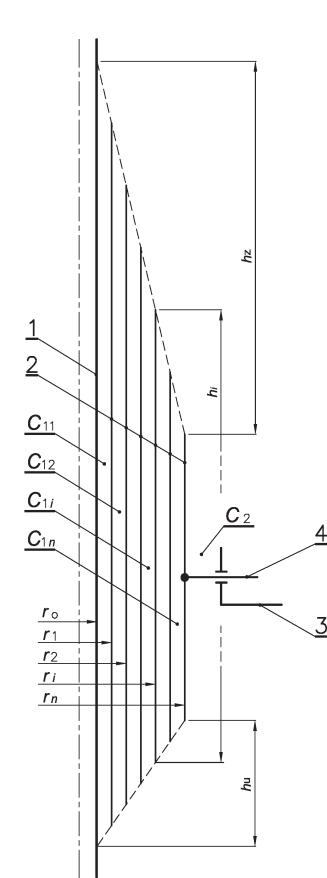
Figure 2: Bushing condenser body (schematically)

Designations, Figure 2:

- 1 – Central tube
- 2 – Electrodes
- 3 – Flange
- 4 – Test tap
- C_{1i} – Capacitor, i^{th} in line
- r_i – Radius of the i^{th} electrode
- h_i – Height of the i^{th} electrode
- h_z – Slope of the aerial part
- h_u – Slope of the oil part
- C_1 – Condenser body capacitance
($1/C_1 = 1/C_{11} + \dots + 1/C_{1i} + \dots + 1/C_{1n}$)
- C_2 – Test tap capacitance
